Technical Bulletin

ICOM

IC-R71/R71AJ

GENERAL COVERAGE RECEIVER
GJ36783

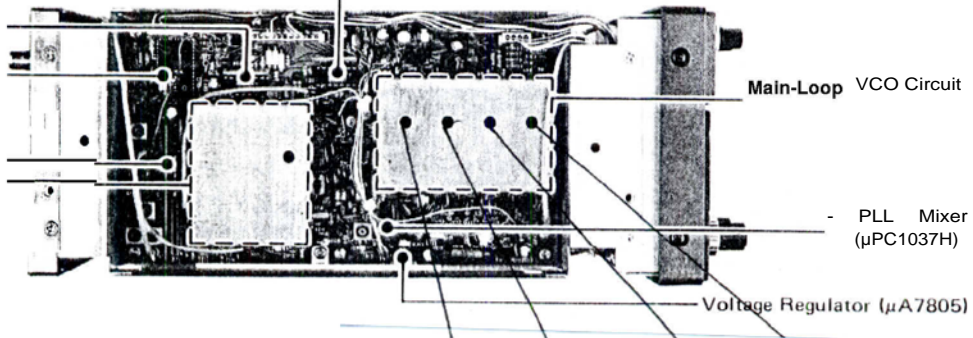
PLL Board

The trimmer caps in the PL unit may have aged and changed values.

C78 C88 C97 C107

Replace the following trimmer caps:

C78	10pf	with an Icom # 4610000110 12pf unit VCO cap (white)
C88	10pf	with an Icom # 4610000110 12pf unit VCO cap (white)
C97	6pf	with an Icom # 4610000100 6pf unit VCO cap (red)
CI07	6pf	with an Icom # 4610000100 6pf unit VCO cap (red)

We recommend that you remove the excessive sealing wax from around replacement trimmer caps to prevent future contamination. We also recommend that you check the REG unit circuit board for cracked or cold solder joints. The circuit is adjacent to the PL unit.

The replacement trimmer caps are long-life ceramics. A partial realignment is required after these trimmers are replaced. See Service Manual for procedure.
