Technical Bulletin

ICOM

IC-R71/R71AJ

GENERAL COVERAGE RECEIVER
GJ36783

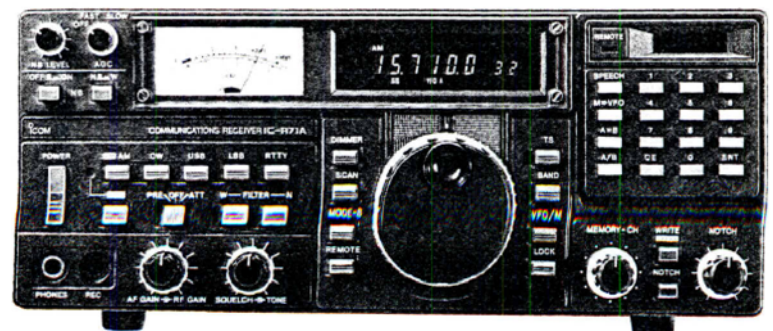
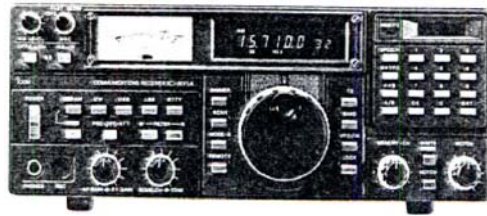
Distorted receive and/or transmit audio on one or more bands. Audio may cut out completely. Distortion may be temperature related. Single sideband audio sounds "raspy" or "rough". Selected frequency may show instability.

The trimmer caps in the PL unit may have aged and changed values.

Replace the following trimmer caps:

C78	10pf	with an Icom # 4610000110 12pf unit VCO cap (white)
C88	10pf	with an Icom # 4610000110 12pf unit VCO cap (white)
C97	6pf	with an Icom # 4610000100 6pf unit VCO cap (red)
CI07	6pf	with an Icom # 4610000100 6pf unit VCO cap (red)

We recommend that you remove the excessive sealing wax from around replacement trimmer caps to prevent future contamination. We also recommend that you check the REG unit circuit board for cracked or cold solder joints. The circuit is adjacent to the PL unit.

The replacement trimmer caps are long-life ceramics. A partial realignment is required after these trimmers are replaced. See Service Manual for procedure.
